Stream Inventory Report

Nolan Creek

Salmon Creek Watershed
Sonoma County, California

Survey: Summer 2003
Final Report: September, 2004
Revised May 2007

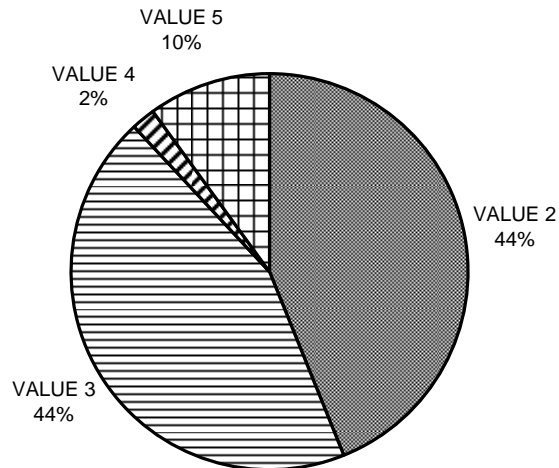
GRAPH 6. Percent embeddedness estimated at pool tail-outs.

The depth of cobble embeddedness was estimated at pool tail-outs. Of the 66 pool tail-outs measured, 29 had a value of 2 (44%), 29 had a value of 3 (44%) and 1 had a value of 4 (2%) (Graph 6). Seven (11%) riffles rated a 5 (unsuitable substrate type for spawning). On this scale, a value of one is best for fisheries. Gravel was the dominant substrate observed at pool tail-outs (Graph 8). No mechanical gravel sampling was conducted in 2003 surveys due to inadequate staffing levels.

Forty-five percent of the pool tail-outs measured had embeddedness ratings of either 3 or 4. None had a rating of 1. Cobble embeddedness measured to be 25% or less (a rating of 1) is considered best for the needs of salmon and steelhead. In a reach comparison, Reaches 2 and 3 had the best ratings and Reaches 1 and 4 had the poorest ratings.

The higher the percent of fine sediment, the lower the probability that eggs will survive to hatch. This is due to the reduced quantity of oxygenated water able to percolate through the gravel, or because of fine sediment capping the redd and preventing fry emergence. In Reaches 1, 2 and 3 of Nolan Creek, sediment sources should be mapped and rated according to their potential sediment yields, and control measures taken.

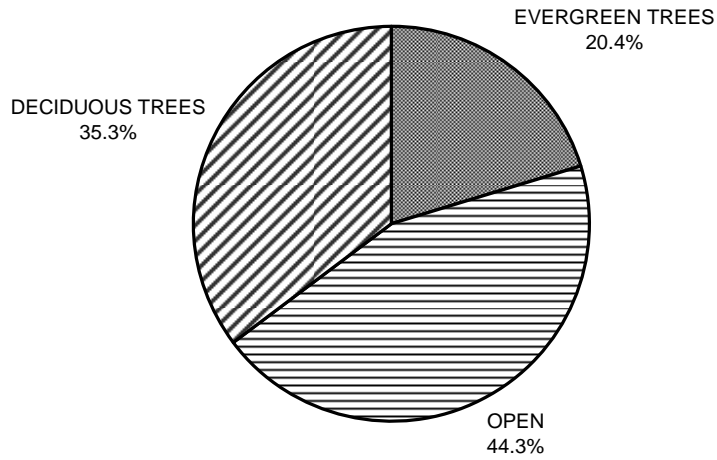
GRAPH 9. Mean percent canopy.

The mean percent canopy density for the stream reach surveyed was 56%. The mean percentages of deciduous and evergreen trees were 63% and 37%, respectively (Table 7). Graph 9 describes the canopy for the entire survey and Table 9 describes the canopy by reach.

The mean percent canopy for the survey was 54%. This is a low percentage of canopy, since 80 percent is generally considered desirable. The riparian buffer is thin or nearly absent in areas with livestock. Riparian removal from intensive grazing within the riparian corridor could lead to less stream canopy and channel incision causing bank erosion and higher water temperatures. Reach 1 had a mean canopy density of 19% with bank

- 3) Increase the canopy on Nolan Creek by planting willow, alder, redwood, and Douglas fir along the stream where shade canopy is not at acceptable levels (portions of Reach 1). The non-anadromous reach above the survey section should be assessed for planting and treated as well, since water temperatures throughout are affected from upstream. In many cases, planting will need to be coordinated to follow bank stabilization or upslope erosion control projects.
